## **Enhanced Preliminary Assessment Report:**

### **Swansea Army Housing Units Swansea, Massachusetts**

September 1989

Environmental Research Division  
Argonne National Laboratory  
Argonne, Illinois 60439

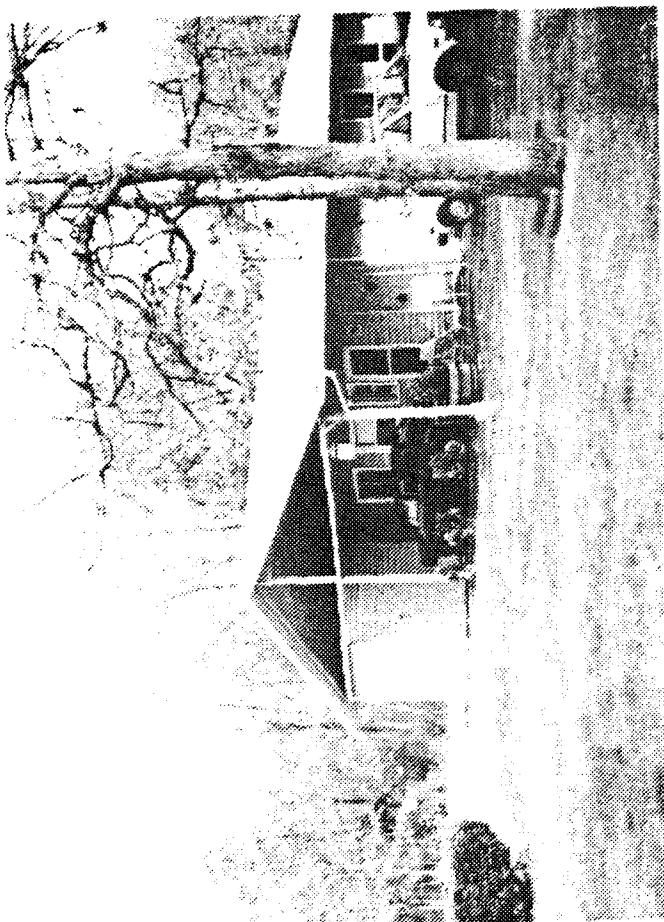
The specific drainage/flooding problem evidenced in 1987 involved sewage washing out of the leach field and mixing with stormwater runoff in a storm drain and ditch.<sup>15</sup> From the ditch, the contaminated water flowed off the installation through a culvert and to a wooded area across Sharps Lot Road. Two recommendations were made to deal with the situation: replacement of all plumbing fixtures with flow-limiting devices and removal of garbage disposals.<sup>14</sup> No records show that the recommendations were acted on. These measures would increase the retention time of waste in the septic tanks, while also reducing the amount of suspended solids entering the system. The measures were acknowledged as addressing only part of the long-term problem.

Lower left-hand photo: Private residence to the north of the housing area, reportedly flooded by Army housing septic problems.

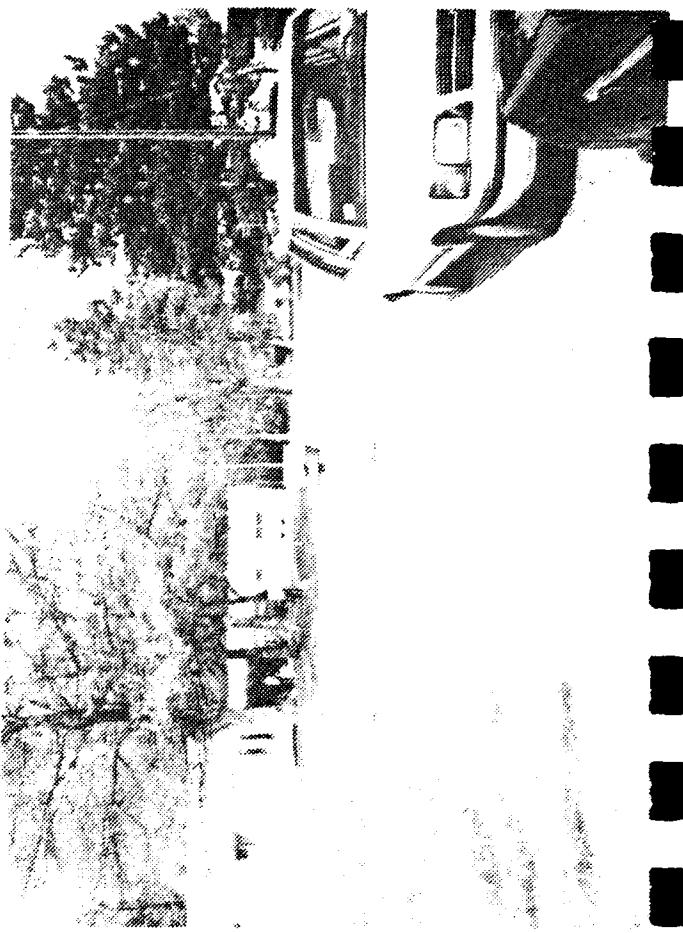
Each unit has a 275-gallon underground fuel tank in front of the house. The fill pipe is located in front of each house, and most areas around the pipe evidenced staining of the soils. Although no documentation was found to indicate failures or suspected leaks in any of these tanks, records manifest that the tanks date to the original construction and are thus more than 30 years old. Circumstantially then, potential environmental risk results from the continued use of these tanks.

Lower right-hand photo: Fill pipe for an underground storage tank at the rear of a house.

Because the original heating-oil tanks are still in place underground at this property, and are assumed to be near or at the end of their expected useful life, it is recommended that all underground tanks be removed and replaced with new tanks. It is also recommended that soil tests be taken in all portions of the tank excavations to identify any contamination that may be present.

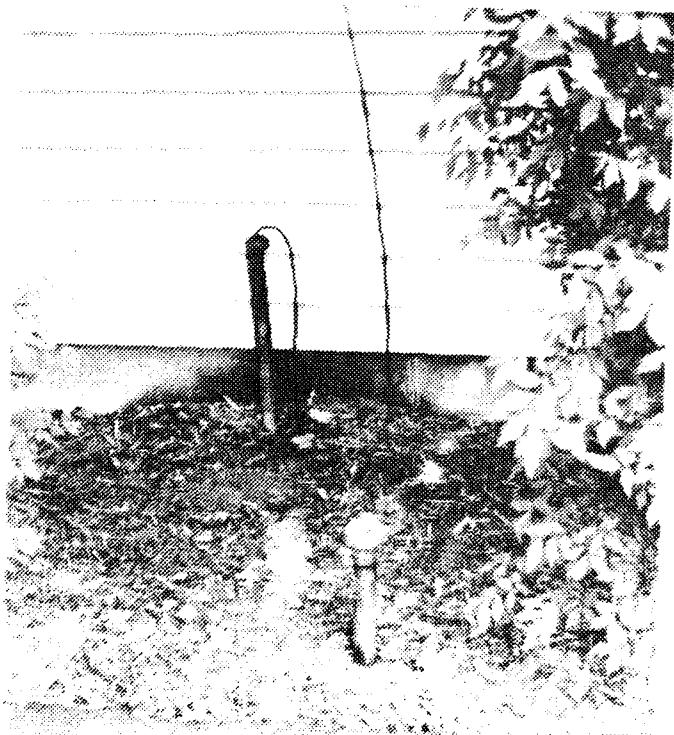
A concern involves the underground heating-oil tanks at each housing unit on the property. Although there is no documentation reporting a failure or suspected leak in any of these tanks, real property records indicate they are more than 30 years old and there is no record of them being covered with cathodic protection or protective coatings when they were installed. Circumstantially, then, each of these tanks may be at or near the end of its effective use. Since no deliberate attempt has been made to characterize the integrity of any of these tanks, their continued use makes the possibility of an environmental release real but the likelihood of this happening unknown. Furthermore, the often saturated condition of the soils at this property can be expected to have aided corrosion of the tanks and associated plumbing.

- Develop and implement a permanent solution to the sewage-treatment problems.
- Remove and replace underground heating-oil tanks at all units on the property, sampling soils in all portions of the tank excavations to identify any possible areas of contamination.
